Gas Flow Troubleshooting

In the Field with the GE Panametrics TransPort PT878GC Ultrasonic Gas Flow Meter

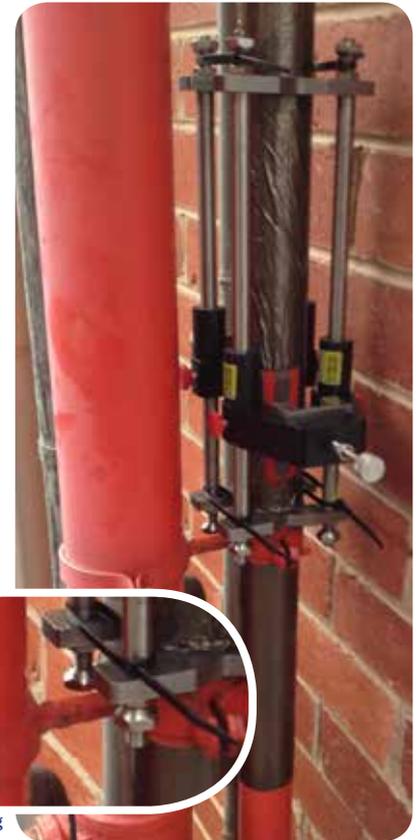
Graeme then further investigated by implementing proper test procedure and viewing the results. It was soon found that errors were indeed frequent, and only intermittent performance was attainable. A physical inspection of the unit mounting and pipes then followed, and it was discovered that when touching a small strip of metal used for spacing of the pipe in question to an adjacent pipe, a steady reading was possible. This implied that the pipe was not properly deadened although the damping appeared to be more than sufficient.

The small strip of metal was not thought to be close enough to directly influence the transducer signals, and it was assumed that the damping all around it would negate any overt contributions. But as the physical examination suggested otherwise, corrective measures were implemented.

Connector causing interference

It was determined that the connector would be damped and the entire apparatus would be mounted further away from the connector. Running the test protocol with the new set up yielded steady, error free results, and the customer was able to successfully audit the compressed air flow in the pipe.

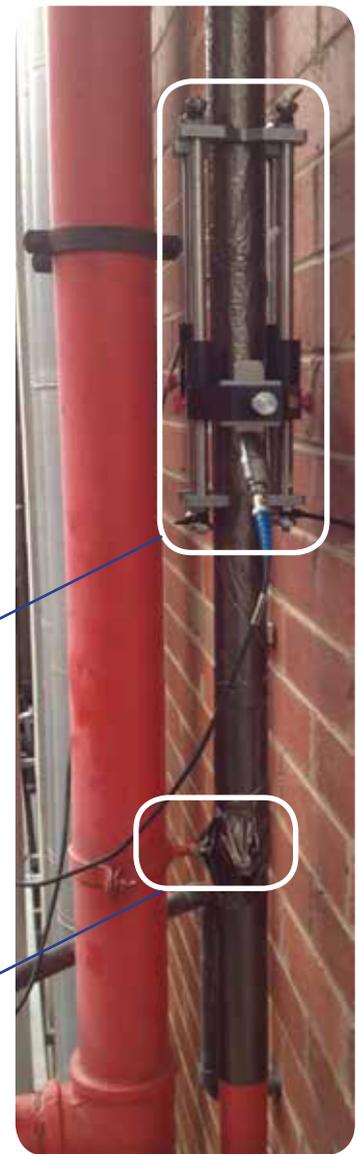
Relocated apparatus

Extra damping
